M6 SOUTH NAPA EARTHQUAKE

August 24, 2014

MRP Engineering Summary Report

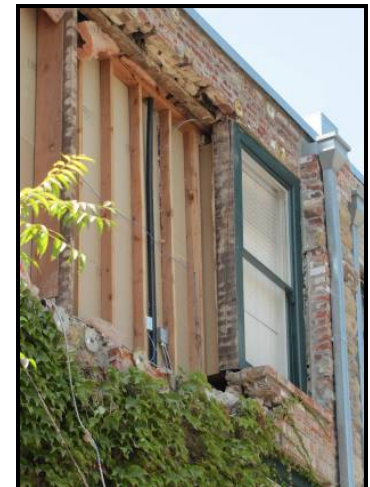
Masonry wall failure in a building retrofitted with wall anchors at roof and floor levels.

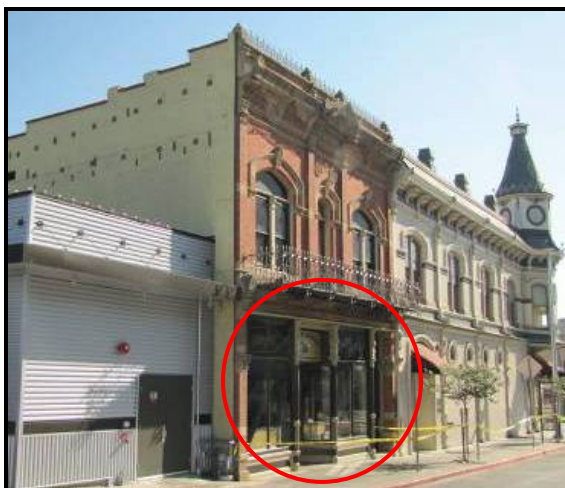
Retrofitted URM building that survived the earthquake. Upgrades included wall anchors and a steel braced frame at storefront.

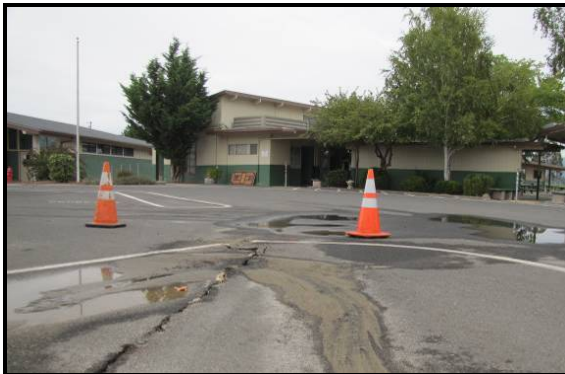
Ground rupture in an elementary school parking lot south of Napa resulted in fracture of underground water piping.

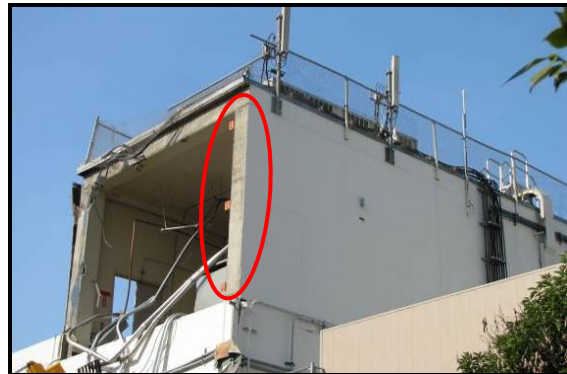
Precast concrete wall panel connections failure at a local telecom hub damaged HVAC system at this critical facility.

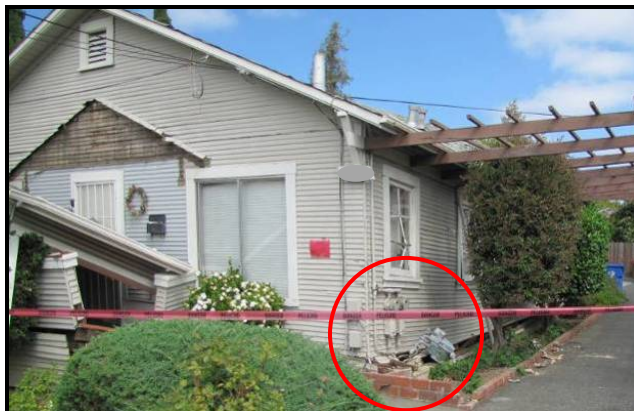
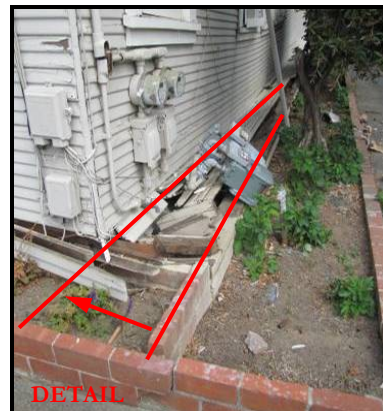
Residential wood-framed structures that predate modern seismic design consideration can shift from their foundations when short wood-framed walls are present surrounding the crawl space below the main floor. These common failures can lead to a fire-following-earthquake hazard from severed natural gas piping and nearby electrical components. Correcting this condition involves installation of plywood sheathing with floor and foundation connections.
