**SAUNDERS**  
COMMERCIAL SEISMIC RETROFIT  
www.saundersseismic.com

## ROOF CONDENSATION: A COSTLY PROBLEM

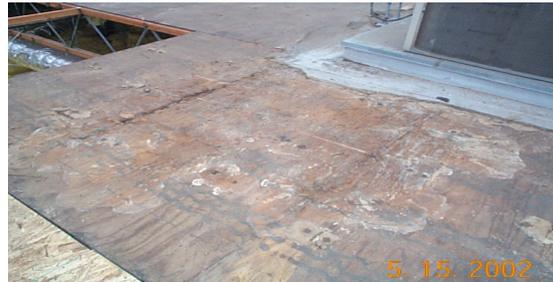
**Roof Leaks** - Over time a roof may suffer minor or major leaks that allow moisture into the roof wood system, which of course, becomes trapped by the insulation.

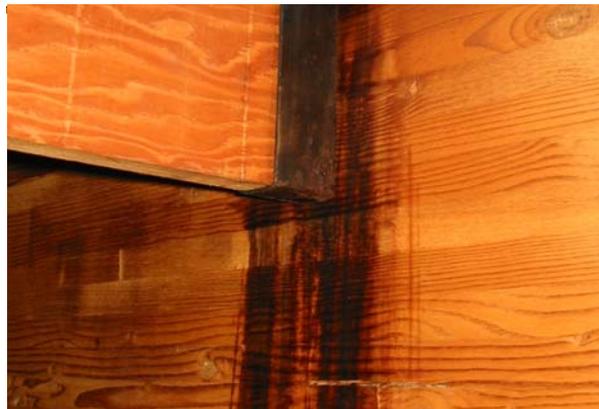
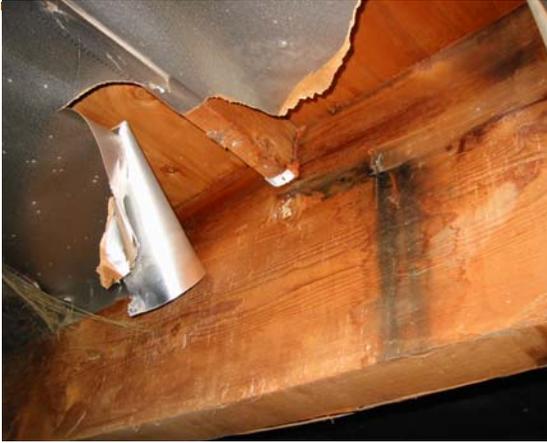
When you enter a concrete tilt-up building with a foil barrier attached to the bottom of the sub-purlins or wrapped around the purlins (one of the worst cases), you may find black (dark) streaks running down from some or all of the purlin hangers. This is an indication of a roof condensation problem.

If you can see a white surface at the bottom of the sub-purlin hanger(s), the condensation process is affecting these hangers as well. In more severe cases, the sub-purlin hanger is rusting and is becoming ineffective.

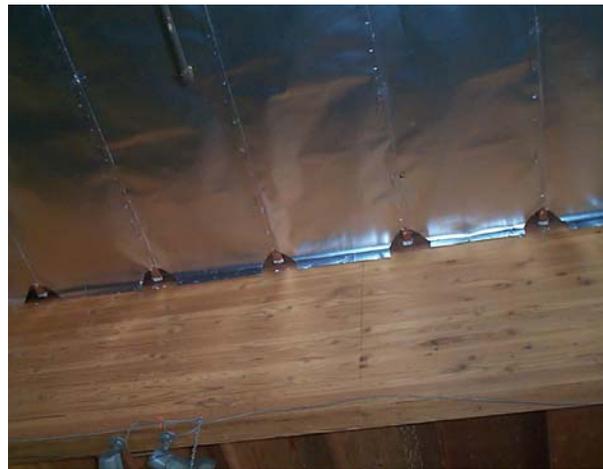
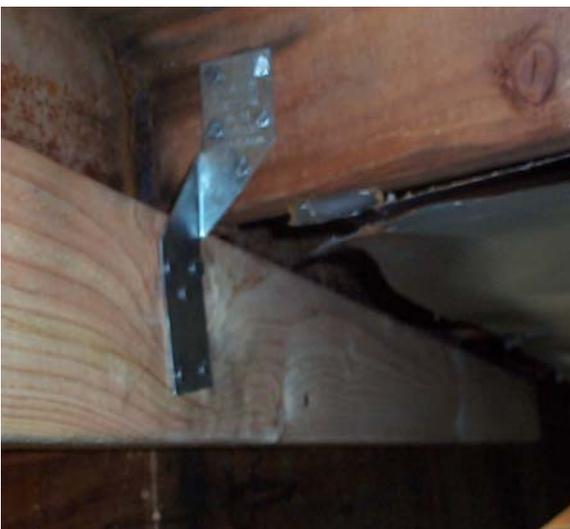
**Option #1-Vent or Remove Foil** - The existing foil insulation can be removed or vented by cutting the edges of the foil back 2-3 inches from the area where the foil attaches to the other wood members like purlins and/or a Glue Laminated Beam (GLB), enabling the foil to breathe. The building must be vented and allowed to dry out.

(This picture shows V-cuts in the foil. Typically, this is used at loading dock areas due to wind)

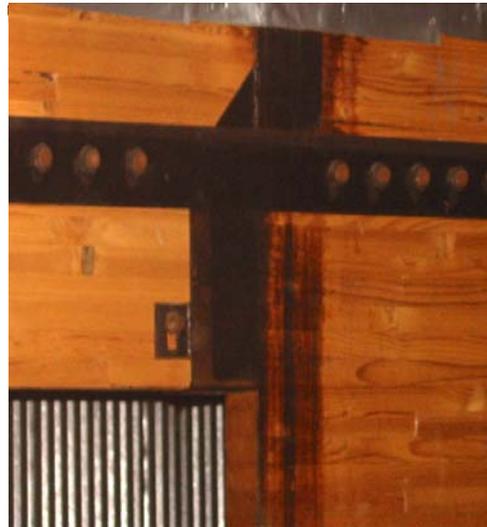
**Option #3** – Install GLB connections - GLB connections first need to be inspected for rusting. In cases where the hanger is staining the beam it is attached to, but is not severely corroded, the hanger can be cleaned with a wire brush and coated it with a rust inhibitor like “Rust Grip,” which seems to perform very well. After cleaning and coating an existing hanger that is severely rusted, a retrofit hanger can be added over the existing one. The new hanger is protected from possible transfer of corrosion by putting plastic or duct tape between the hangers. An alternate to the wrap-around retrofit hanger solution is to use an 8 to 10 inch long piece of angle iron to support the existing purlin hanger at the bottom by installing one side to the GLB and the other side of the angle tight to the bottom of the existing purlin hanger. If the rusting is too severe to be fixed by grinding and painting the GLB hinge connector, a structural detail will be required. (There are too many loading issues to have a standard solution.)

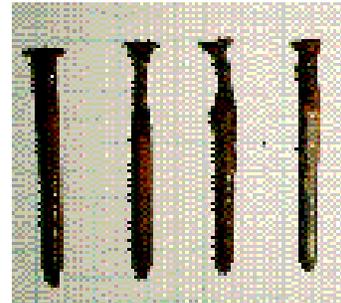
**Option #4** - Roof Nailing – A disruption to the roof nailing is possibly one of the worst conditions of roof condensation that can exist. Moisture absorbed by the roof sheeting can affect the roof nailing (roof diagram) and the shear value of the plywood. This is what holds the building together at the roofline. Unfortunately, this problem can easily go undetected by roofing, HVAC, insulation, and other contractors.

The solution begins with an inspection of roof area nailing to determine if the shanks of the nails are being affected. If in fact the nails are deteriorated, the roof needs to be removed and the plywood roof has to be re-nailed or re-stapled. Another option is to install anchors underneath the roof and attach them to the plywood and the structural roof members. This option is time consuming and expensive.
