**SAUNDERS**  
COMMERCIAL SEISMIC RETROFIT  
www.saundersseismic.com

## WHAT YOU DON'T KNOW MAY COST YOU!

**Roof condensation** is moisture that develops at the roof ceiling area and is trapped by foil insulation or other types of radiant barriers. **IF LEFT UNTREATED, IT CAN DESTROY THE ENTIRE ROOF STRUCTURE!**

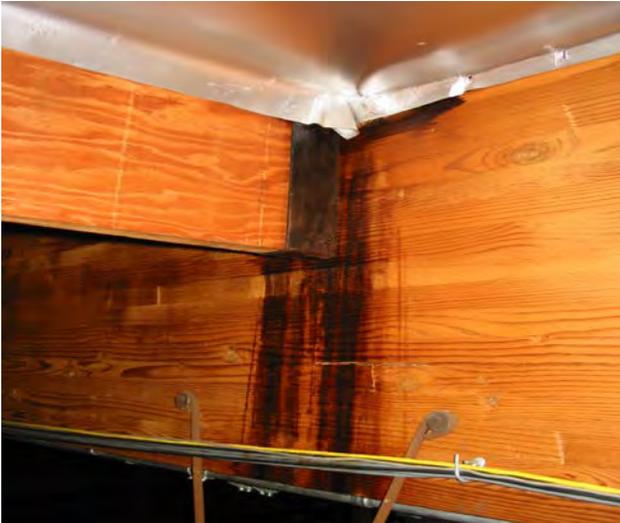
#1

#1- Look for black streaks caused by iron in the purlin hangers.

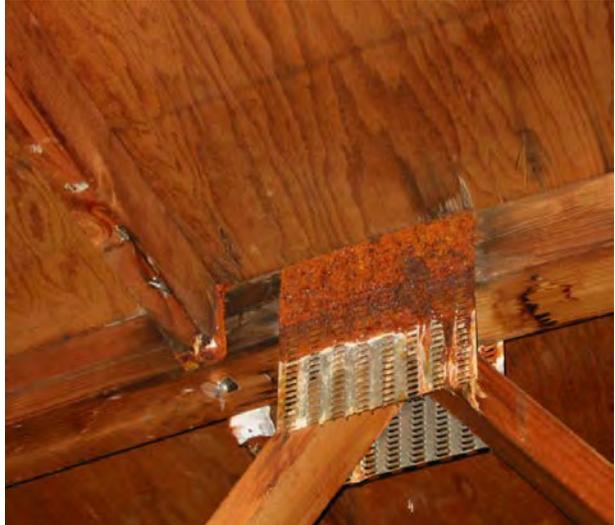
#2

#2- Gang nail plate stamped for trusses- notice most of the rusting above the old foil line. These plates are very thin and stamped when made so they cannot withstand any rusting.

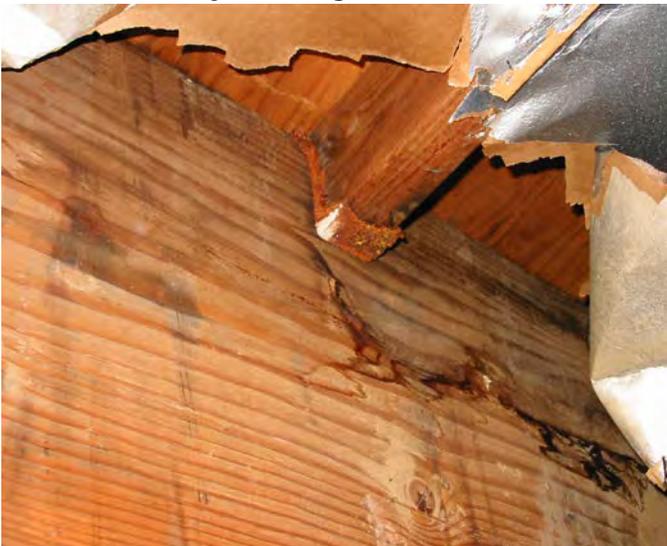
#3

#3- Sub-purlin hangers- These are made from an aluminum alloy and do not rust like metal hangers.

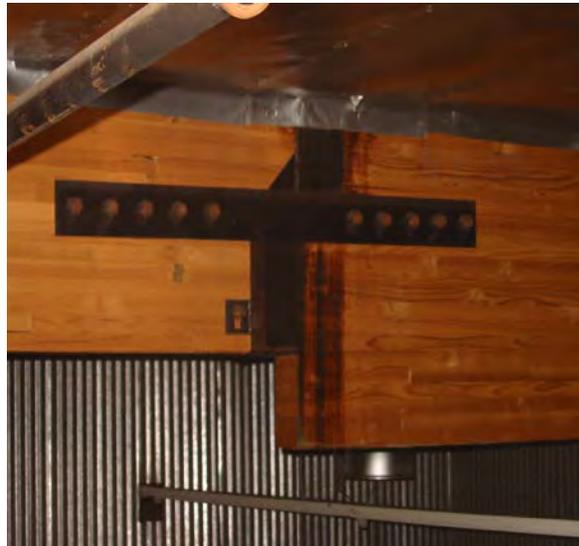
#4

#4- Look for black streaks caused by iron in the GLB (Glue-Lam-Beam) hinge connection.

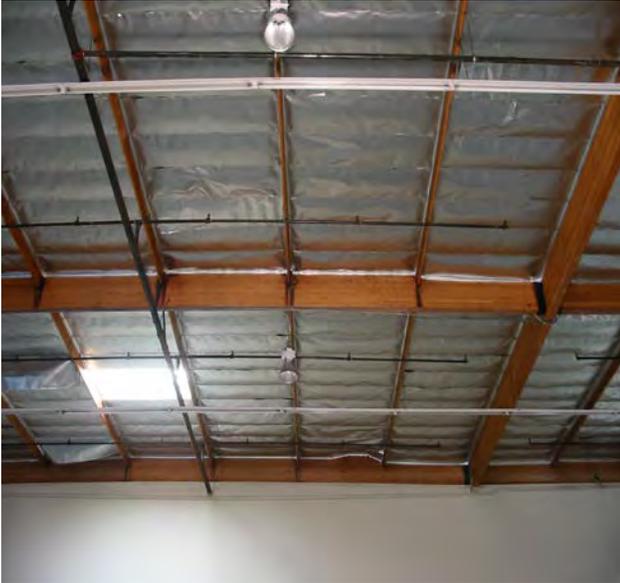
#5

#5&#6- These pictures show what to look for when looking from the ground. All the black streaks indicate the metal hangers are rusting and with this much evidence the sub-purlin hangers are sure to be corroded even though they are covered over by the foil.

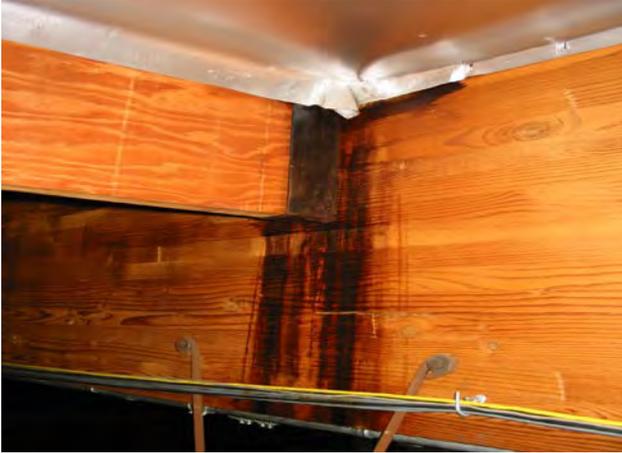
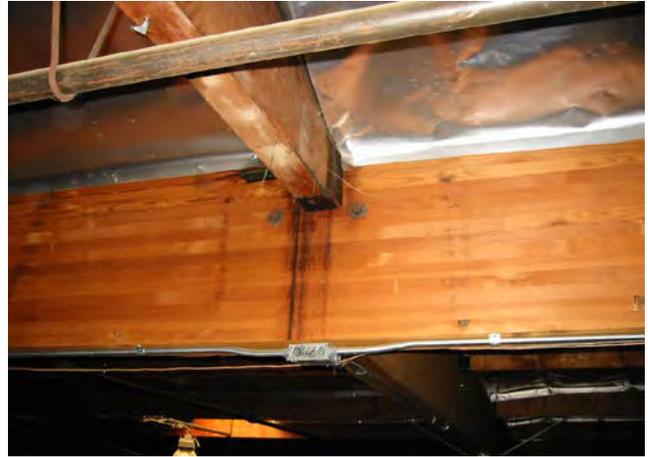
Close up pictures of rusted purlin hangers.

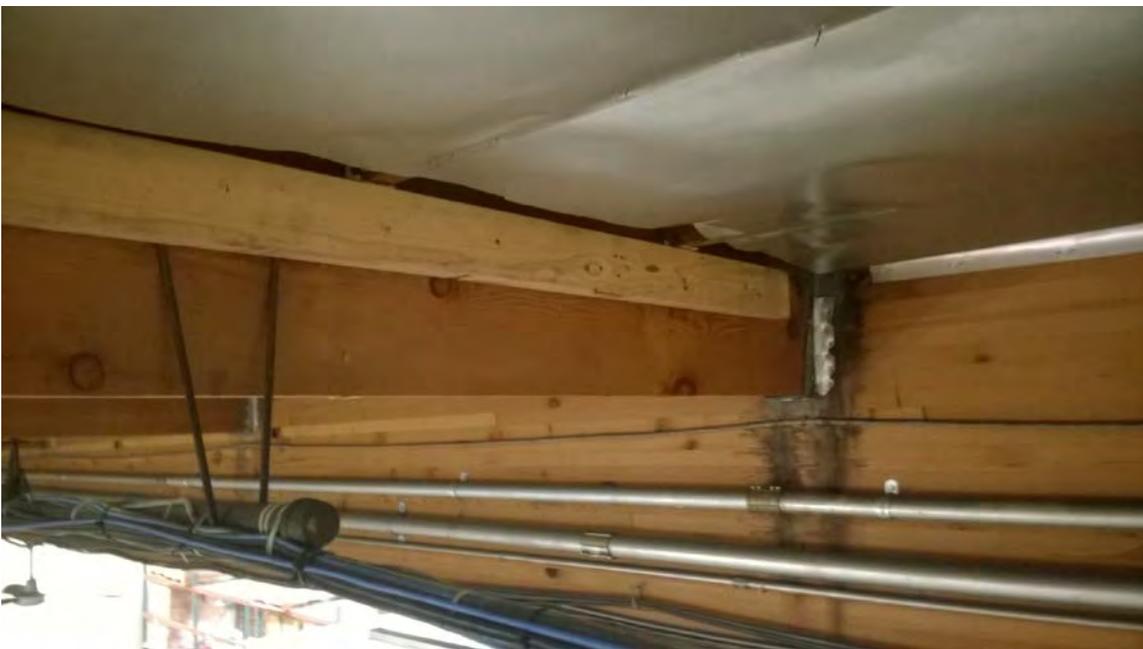
Repair sub-Purlins with 2x4 ledger.

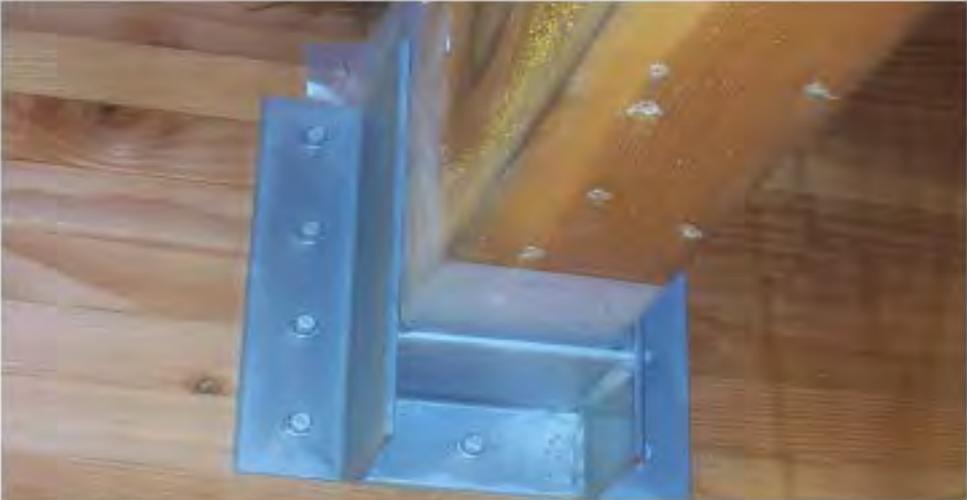
New custom retrofit hanger

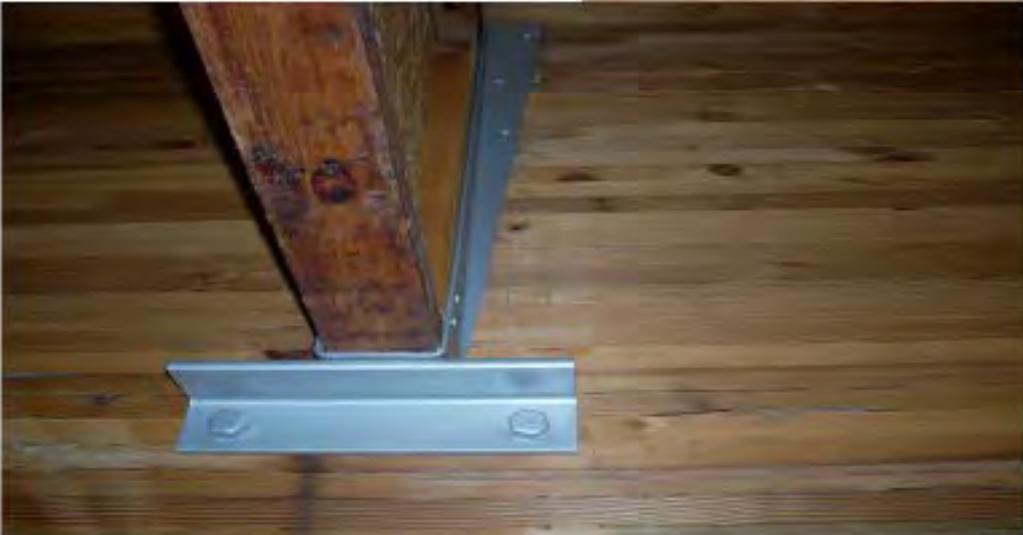
Fabricated Angle Bracket
