SAUNDERS
COMMERCIAL SEISMIC RETROFIT
www.saundersseismic.com
California [License: 616856]
Oregon [License: 193670]
Washington [License: SAUNDCI953ND]

ROOF CONDENSATION A COSTLY PROBLEM

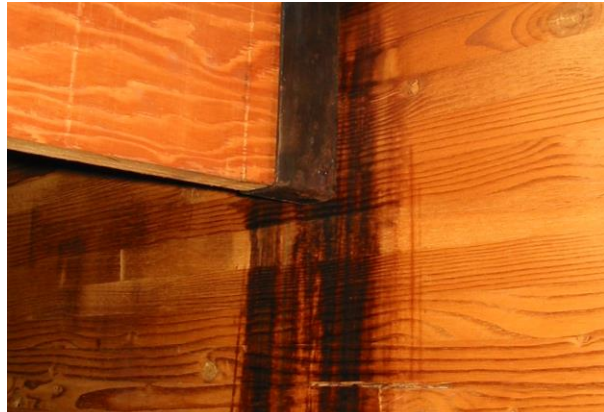
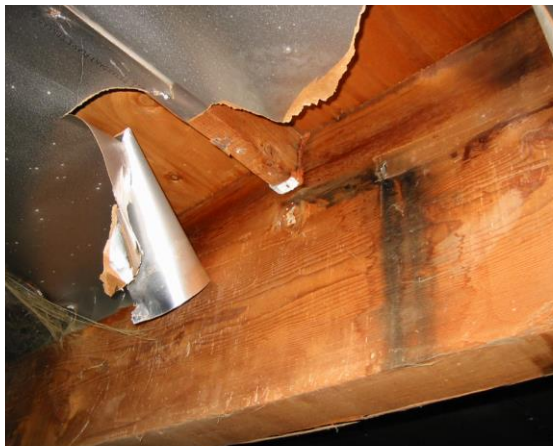
When you enter a concrete tilt-up building with a foil barrier attached to the bottom of the sub-purlins or wrapped around the purlins (one of the worst cases), you may find black (dark) streaks running down from some or all of the purlin hangers. This is an indication of a roof condensation problem.

If you can see a white surface at the bottom of the sub-purlin hanger(s), the condensation process is affecting these hangers as well. In more severe cases, the sub-purlin hanger is rusting and is becoming ineffective.

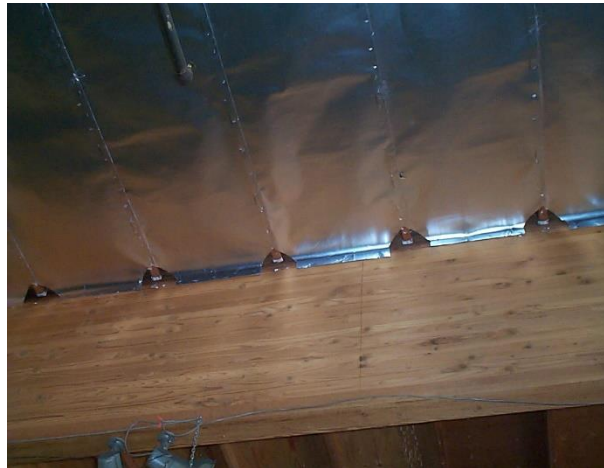
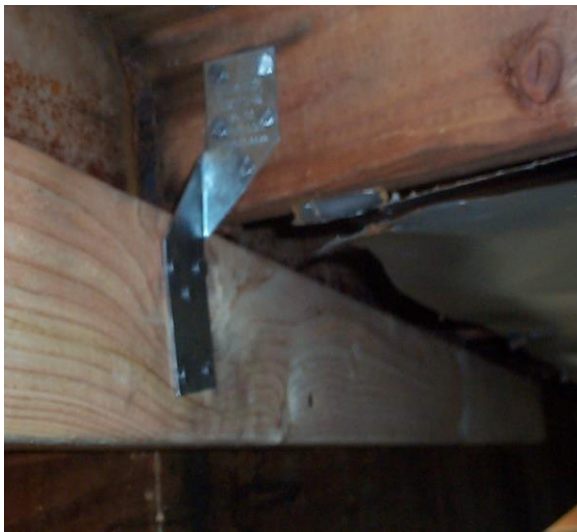
Option #1-Vent or Remove Foil - The existing foil insulation can be removed or vented by cutting the edges of the foil back 2-3 inches from the area where the foil attaches to the other wood members like purlins and/or a Glue Laminated Beam (GLB), enabling the foil to breathe. The building must be vented and allowed to dry out.

(This picture shows V-cuts in the foil. Typically, this is used at loading dock areas due to wind)

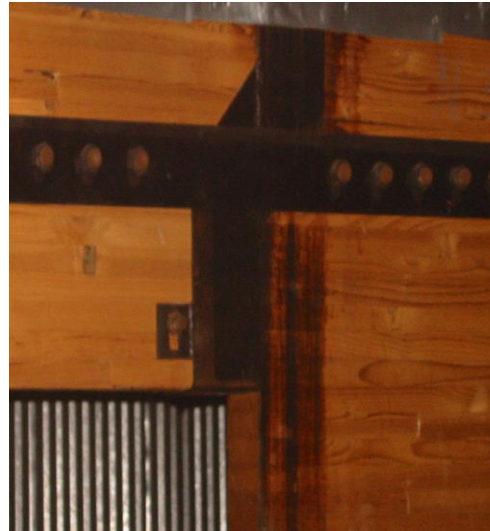
Option #3 – Install GLB connections - GLB connections first need to be inspected for rusting. In cases where the hanger is staining the beam it is attached to, but is not severely corroded, the hanger can be cleaned with a wire brush and coated it with a rust inhibitor like “Rust Grip,” which seems to perform very well. After cleaning and coating an existing hanger that is severely rusted, a retrofit hanger can be added over the existing one. The new hanger is protected from possible transfer of corrosion by putting plastic or duct tape between the hangers. An alternate to the wrap-around retrofit hanger solution is to use an 8 to 10-inch-long piece of angle iron to support the existing purlin hanger at the bottom by installing one side to the GLB and the other side

of the angle tight to the bottom of the existing purlin hanger. If the rusting is too severe to be fixed by grinding and painting the GLB hinge connector, a structural detail will be required. (There are too many loading issues to have a standard solution.)

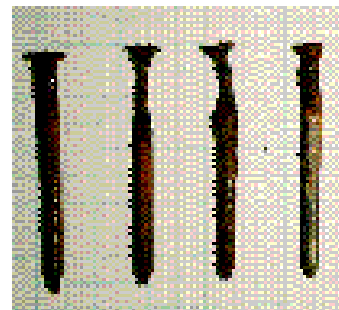
Option #4 - Roof Nailing – A disruption to the roof nailing is possibly one of the worst conditions of roof condensation that can exist. Moisture absorbed by the roof sheeting can affect the roof nailing (roof diagram) and the shear value of the plywood. This is what holds the building together at the roofline. Unfortunately, this problem can easily go undetected by roofing, HVAC, insulation, and other contractors.

The solution begins with an inspection of roof area nailing to determine if the shanks of the nails are being affected. If in fact the nails are deteriorated, the roof needs to be removed and the plywood roof has to be re-nailed or re-stapled. Another option is to install anchors underneath the roof and attach them to the plywood and the structural roof members. This option is time consuming and expensive.
