## IS YOUR ROOF AT RISK? HOW TO SPOT AND FIX CONDENSATION DAMAGE

This guide explains how roof condensation forms, what to look for, and the most effective repair solutions to protect your building from long-term damage.

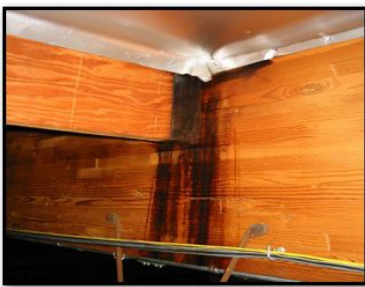
**Dark Streaking on  
Purlin Hangers**

Dark streaks running down from purlin hangers indicate moisture exposure. These streaks result from iron reacting with trapped moisture, a clear sign of condensation-related damage.

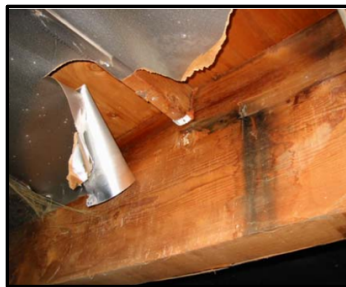
**Discolored/Sagging  
Sub-Purlin Hangers**

If the bottom of the sub-purlin hanger appears white, moisture is affecting the metal. Prolonged exposure to moisture can cause wood framing to warp, weaken, or sag, signaling advanced damage.

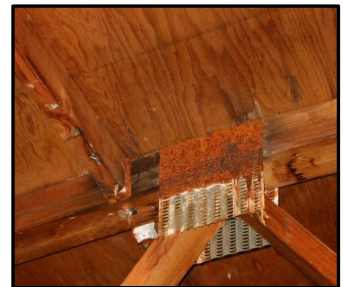
**Rusting Gang  
Nail Plates**

Rust forming above the foil insulation line suggests moisture infiltration, which can weaken critical structural connections.

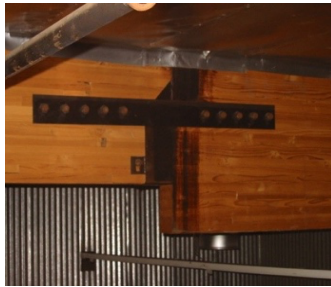
### Black Streaks on Glue-Laminated Beams (GLBs)

Stains on GLB hinge connections indicate ongoing moisture penetration, potentially leading to further deterioration.

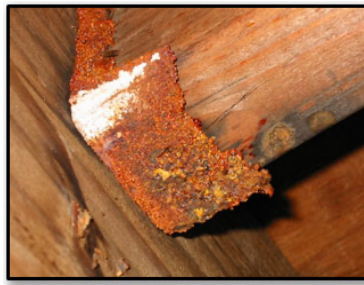
### Corrosion on Metal Components

Any visible corrosion on roof hardware, fasteners, or hangers suggests prolonged moisture exposure and weakening of critical structural connections.

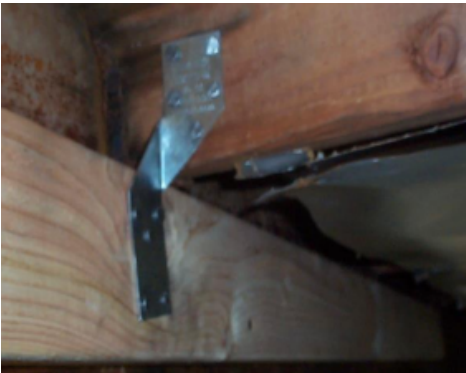
If sub-purlin hangers are corroding, they may no longer securely hold the sub-purlins in place. Installing a 2x4 wood ledger below the sub-purlins, flat against the purlins and ledgers, provides additional structural support.

**Purpose:** Reinforces the existing 2x4 sub-purlins by redistributing weight and compensating for weakened hangers.

**Installation:** Attach the ledger using Simpson SDS screws spaced 1 foot apart to create a strong, stable connection.

**Additional Reinforcement:** Install Simpson H2.5A hurricane clips every 4 feet to hold sub-purlins securely in place and prevent further shifting.

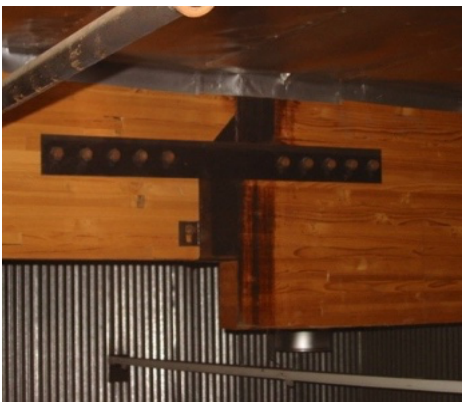
If metal connections show signs of rust, they must be inspected and treated before structural damage worsens.

**Inspection:** Check for rusting or staining on the GLB hanger and beam. Cleaning and protective coating may be sufficient if staining is present but corrosion is minimal.

**Cleaning & Coating:** Light surface rust can be removed with a wire brush, followed by a rust inhibitor like Rust Grip to prevent further corrosion.

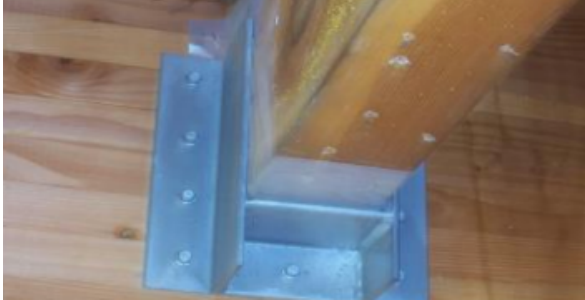
**Retrofit Hanger Installation:** If a hanger is severely rusted, a new hanger can be installed over the existing one. Place a barrier, such as plastic or duct tape, between the old and new hangers to prevent corrosion transfer.

New custom retrofit hanger

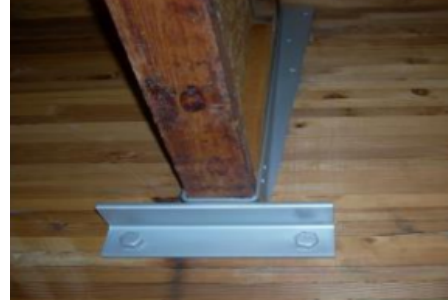
Fabricated angle bracket

**Alternative Support Method:** An 8- to 10-inch-long piece of angle iron can be installed instead of a retrofit hanger. One side is secured to the GLB, while the other supports the bottom of the existing purlin hanger.
