IS YOUR ROOF AT RISK? HOW TO SPOT AND FIX CONDENSATION DAMAGE

3. WHAT TO LOOK FOR: 5 SIGNS OF ROOF CONDENSATION DAMAGE

4. REPAIR OPTIONS

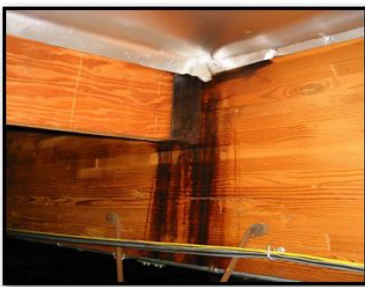
Dark Streaking on Purlin Hangers

Dark streaks running down from purlin hangers indicate moisture exposure. These streaks result from iron reacting with trapped moisture, a clear sign of condensation-related damage.

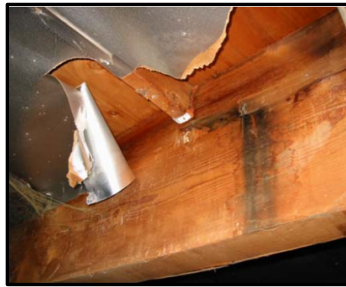
Discolored/Sagging Sub-Purlin Hangers

If the bottom of the sub-purlin hanger appears white, moisture is affecting the metal. Prolonged exposure to moisture can cause wood framing to warp, weaken, or sag, signaling advanced damage.

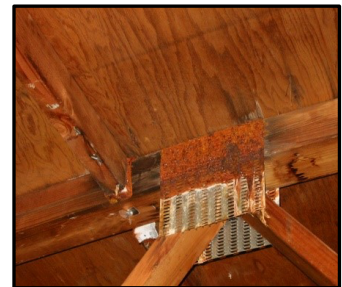
Rusting Gang Nail Plates

Rust forming above the foil insulation line suggests moisture infiltration, which can weaken critical structural connections.

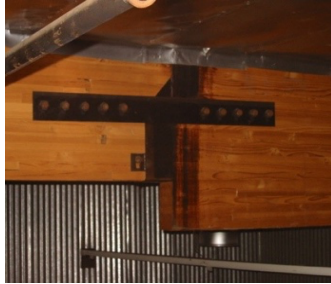
Black Streaks on Glue-Laminated Beams (GLBs)

Stains on GLB hinge connections indicate ongoing moisture penetration, potentially leading to further deterioration.

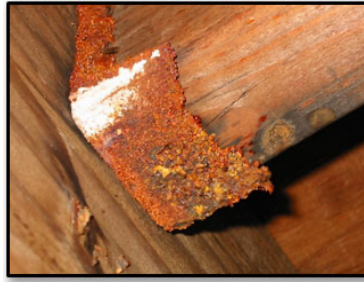
Corrosion on Metal Components

Any visible corrosion on roof hardware, fasteners, or hangers suggests prolonged moisture exposure and weakening of critical structural connections.

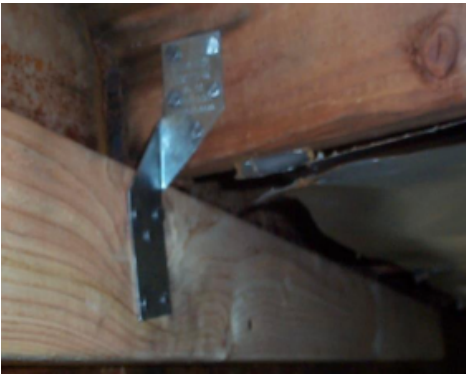
Option 2: Add a Wood Ledger

If sub-purlin hangers are corroding, they may no longer securely hold the sub-purlins in place. Installing a 2x4 wood ledger below the sub-purlins, flat against the purlins and ledgers, provides additional structural support.

Purpose: Reinforces the existing 2x4 sub-purlins by redistributing weight and compensating for weakened hangers.

Installation: Attach the ledger using Simpson SDS screws spaced 1 foot apart to create a strong, stable connection.

Additional Reinforcement: Install Simpson H2.5A hurricane clips every 4 feet to hold sub-purlins securely in place and prevent further shifting.

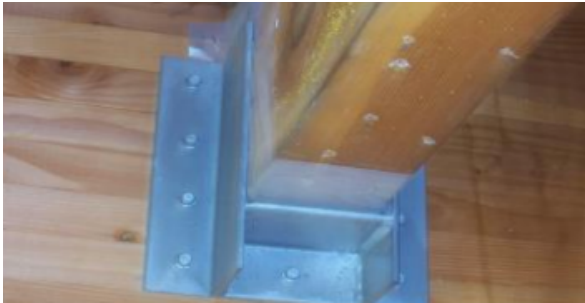
New custom retrofit hanger

Retrofit Hanger Installation: If a hanger is severely rusted, a new hanger can be installed over the existing one. Place a barrier, such as plastic or duct tape, between the old and new hangers to prevent corrosion transfer.

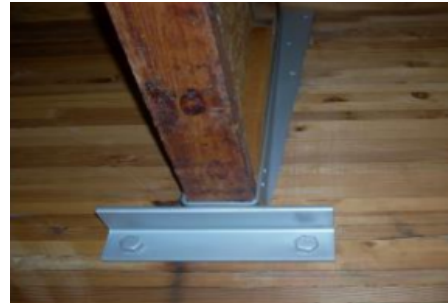
Fabricated angle bracket

Alternative Support Method: An 8- to 10-inch-long piece of angle iron can be installed instead of a retrofit hanger. One side is secured to the GLB, while the other supports the bottom of the existing purlin hanger.
